Accelerated fatigue testing of LM 19.1 blades

Citation (APA):
Kristensen, O. J. D., & Jørgensen, E. (2003). *Accelerated fatigue testing of LM 19.1 blades*. Denmark. Forskningscenter Risoe. Risoe-R No. 1358(EN)

Accelerated Fatigue Testing of LM 19.1 Blades

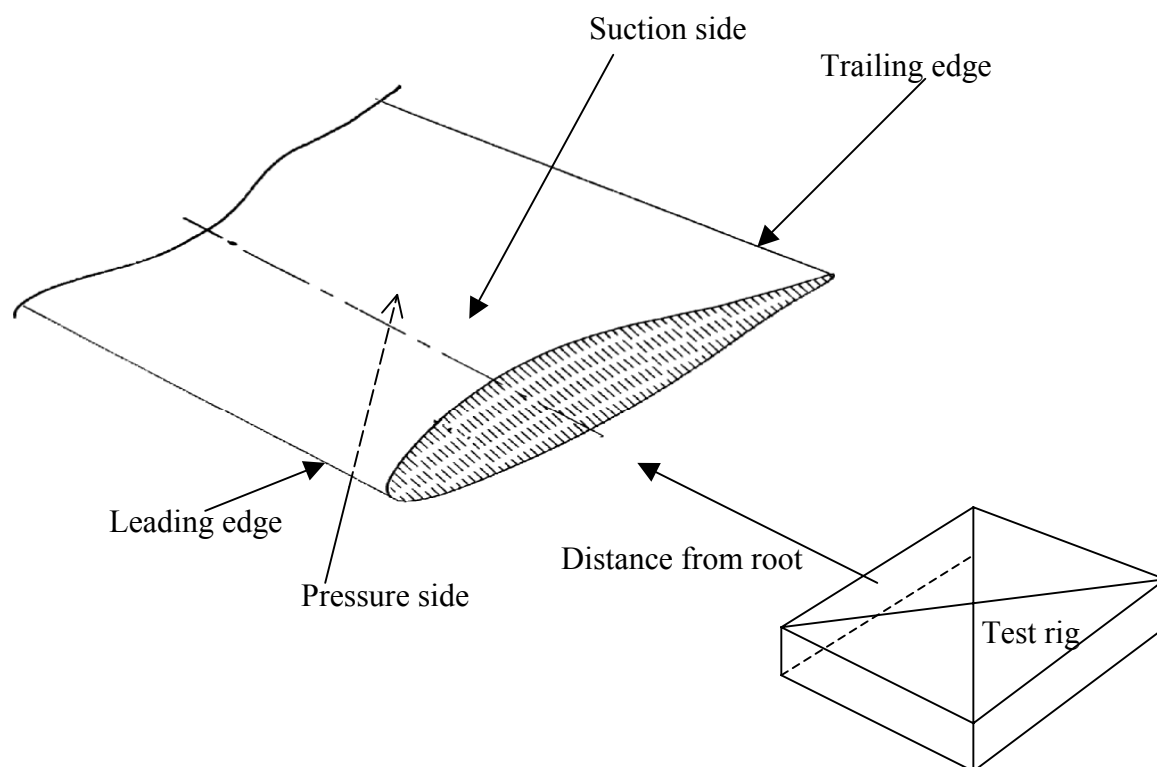
Figure 1. Sketch with the definitions that are used in this report

Distances and forces used in this report are related to a rectilinear co-ordinate system with origin at the blade root interface. The z-axis is parallel to the direction for the 0-degree twist chord (usually the tip chord) see Figure 1.

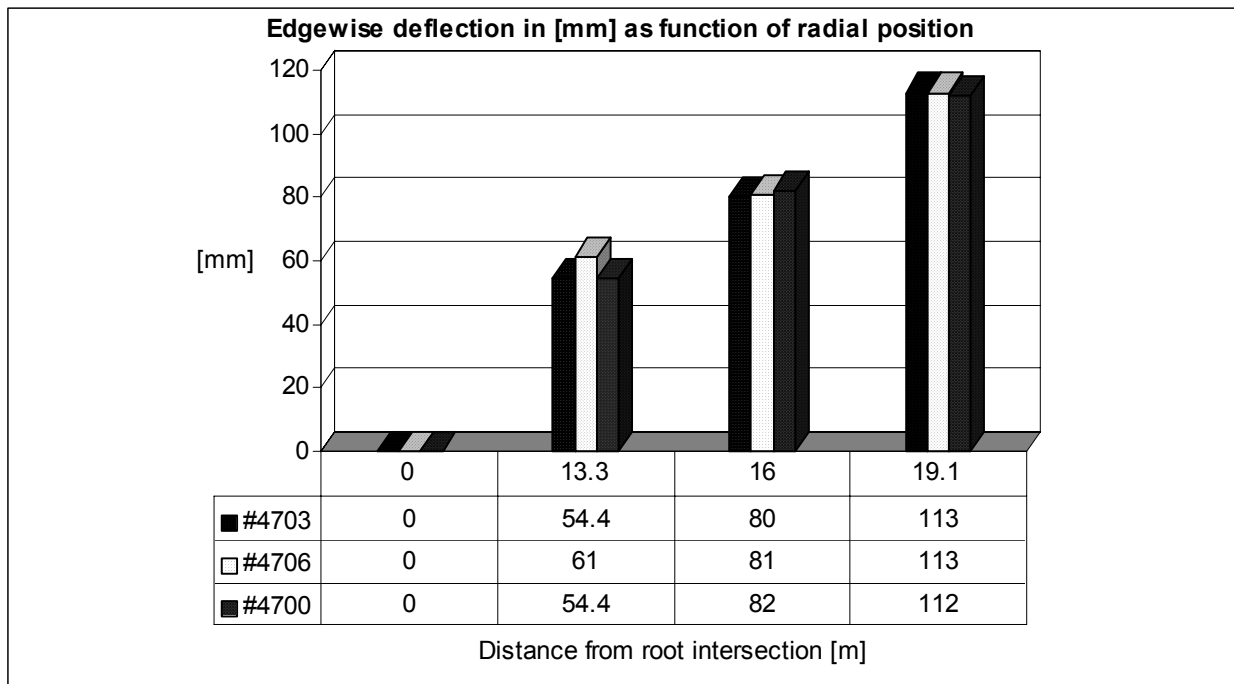
Figure 2. Graphical presentation of edgewise deflection for each of the three tested blades, shown for the highest load step.

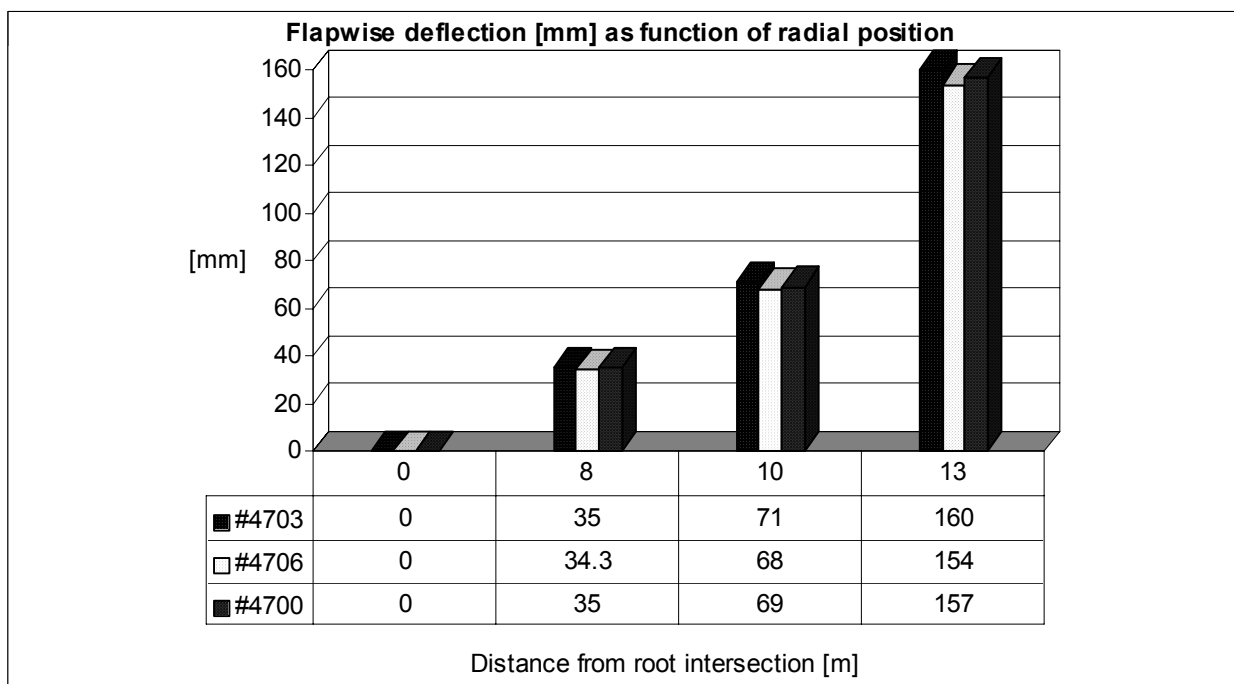
Figure 3. Graphical presentation of flapwise deflection for each of the three tested blades, shown for the highest load step.

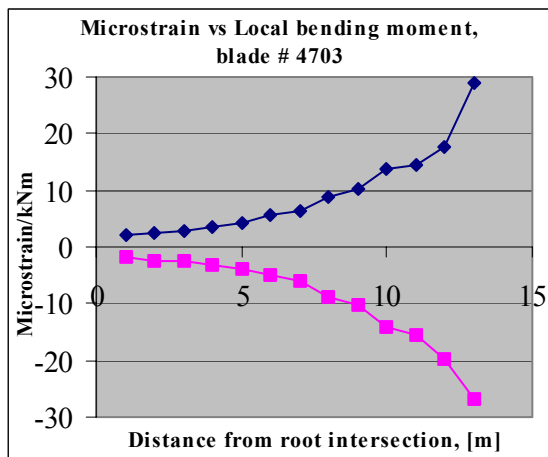
Figure 4. Normative strain distribution for blade # 4703

As the flapwise stiffness determination was carried out just prior to the fatigue test there was also made strain measurements during these tests. The strains measured on the blade are evaluated in correspondence with the applied load, i.e. microstrain vs. local bending moment. Figure 4, Figure 5 and Figure 6 show that blade no. # 4706 and # 4700 are very similar to each other in the sense of lengthwise strain distribution and blade no # 4703 differs a little from the two others.

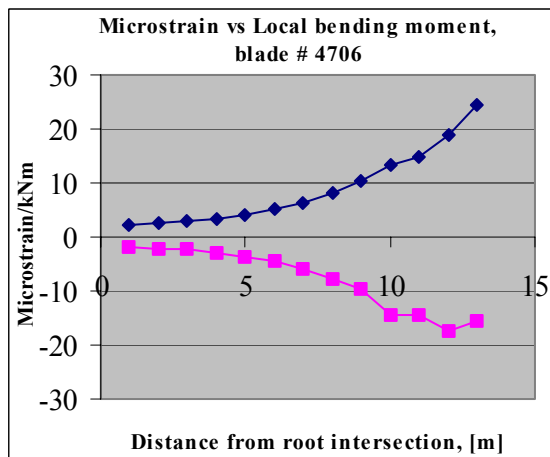
Figure 5. Normative strain distribution for blade # 4706

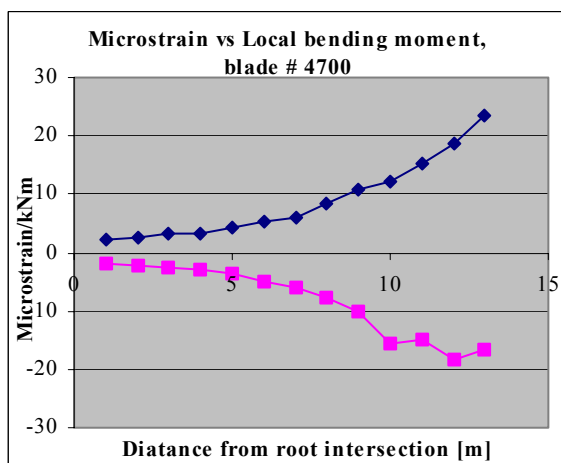
Figure 6. Normative strain distribution for blade # 4700

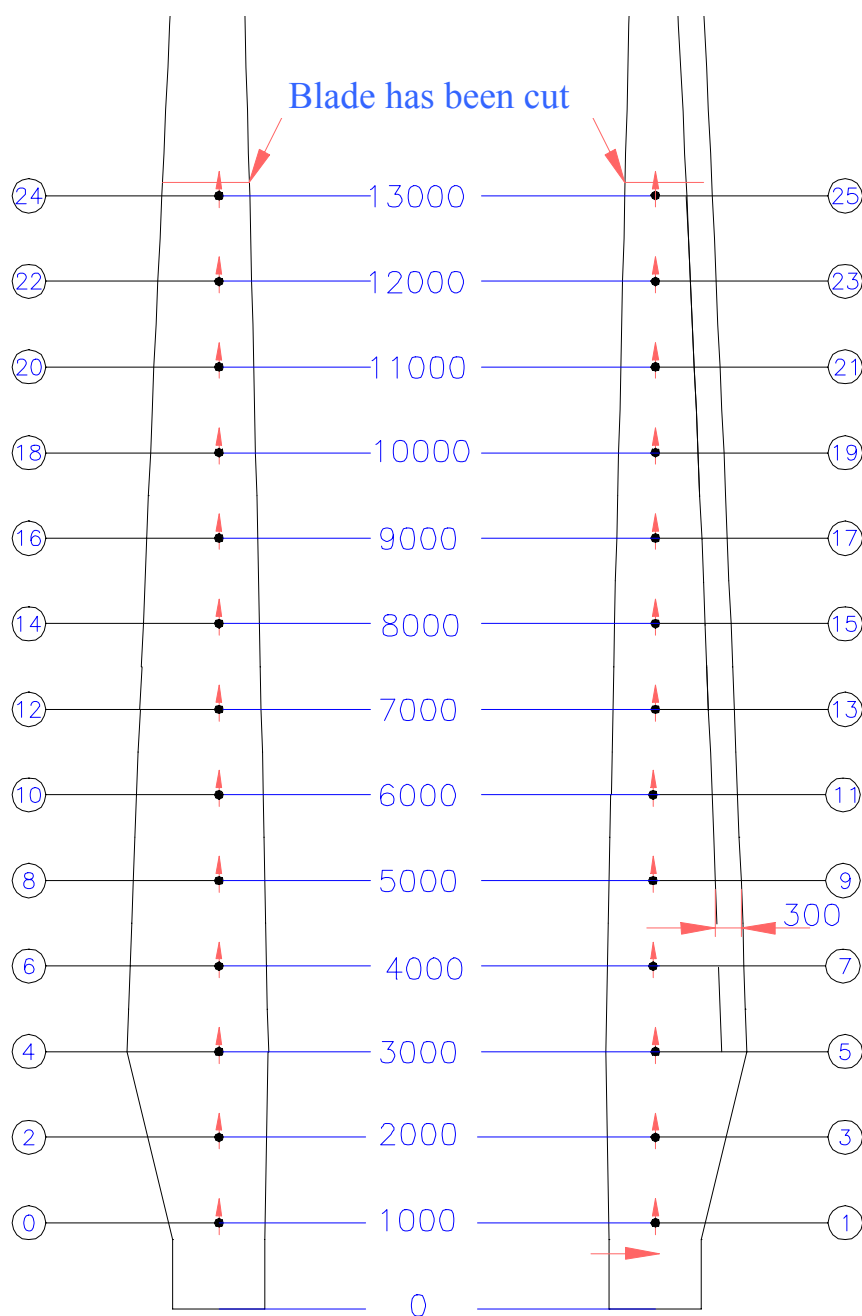
Figure 7. Strain gauge position and numbering, LM 19.1 # 4703, initially.

The strain gauges were of type CEA-06-500UW-350 from Measurements Group, Inc., see appendix C.

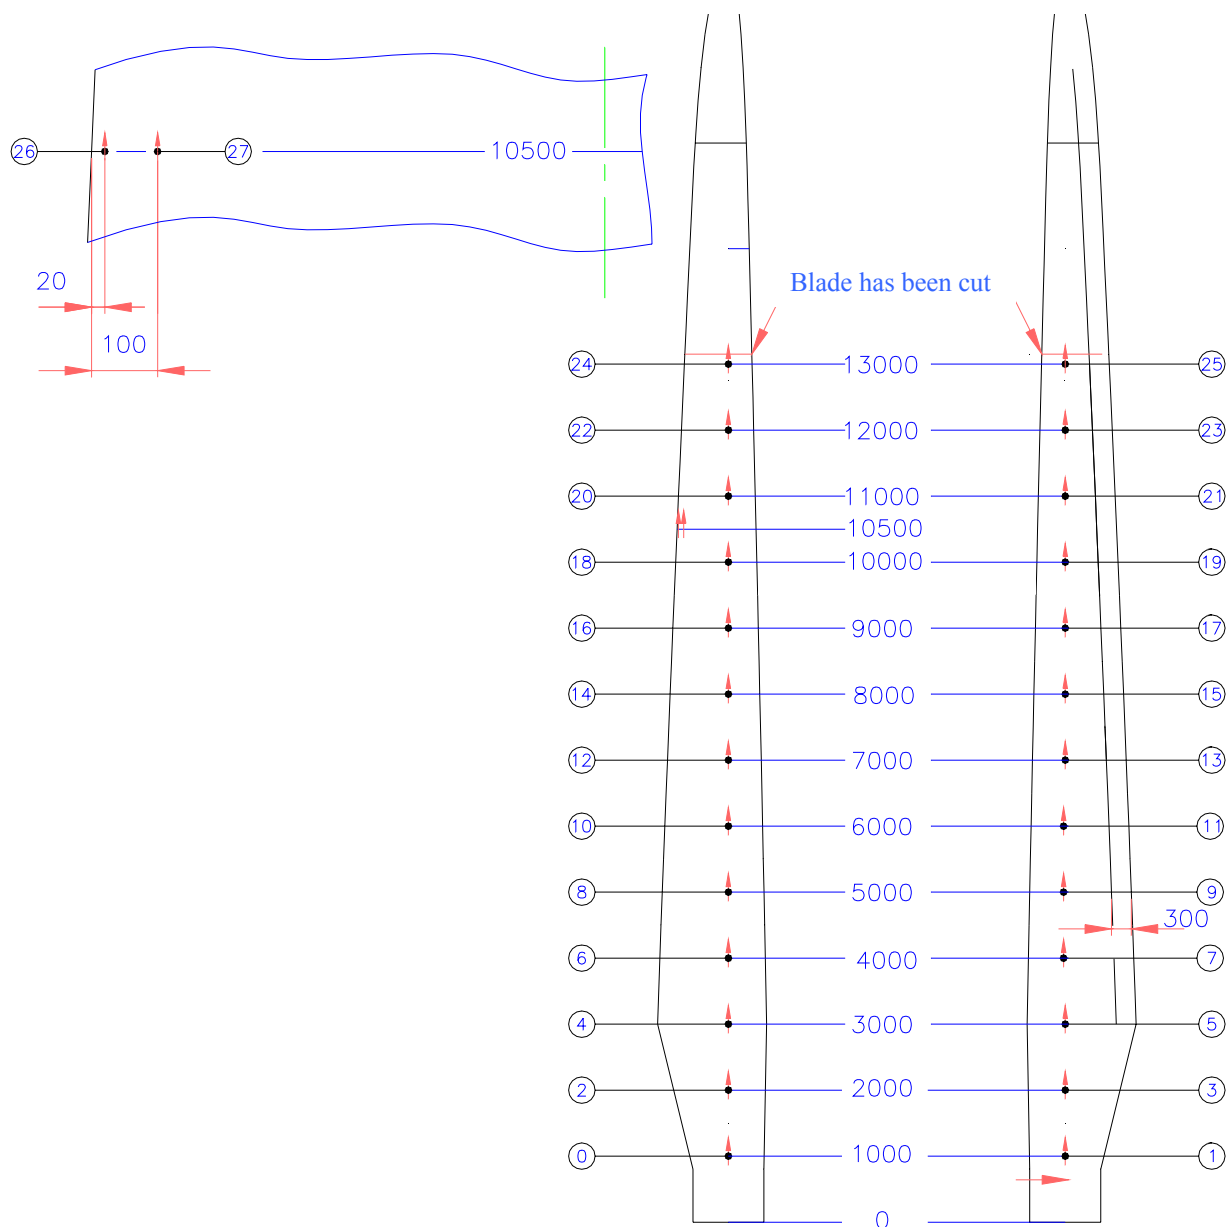
Figure 8. Strain gauge position and numbering, LM119.1 # 4706.

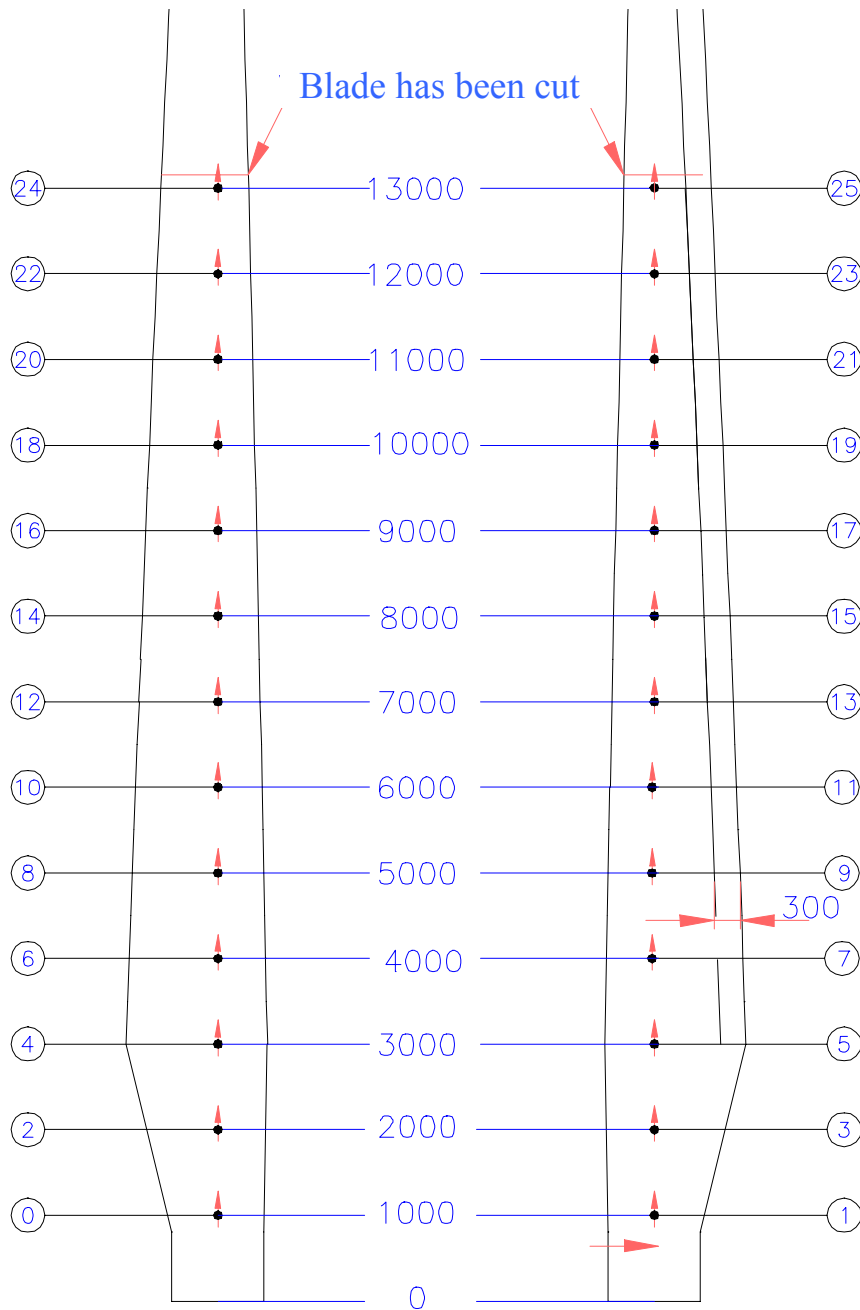
Figure 9. Strain gauge position and numbering, LM 19.1 # 4700.
Test set-up

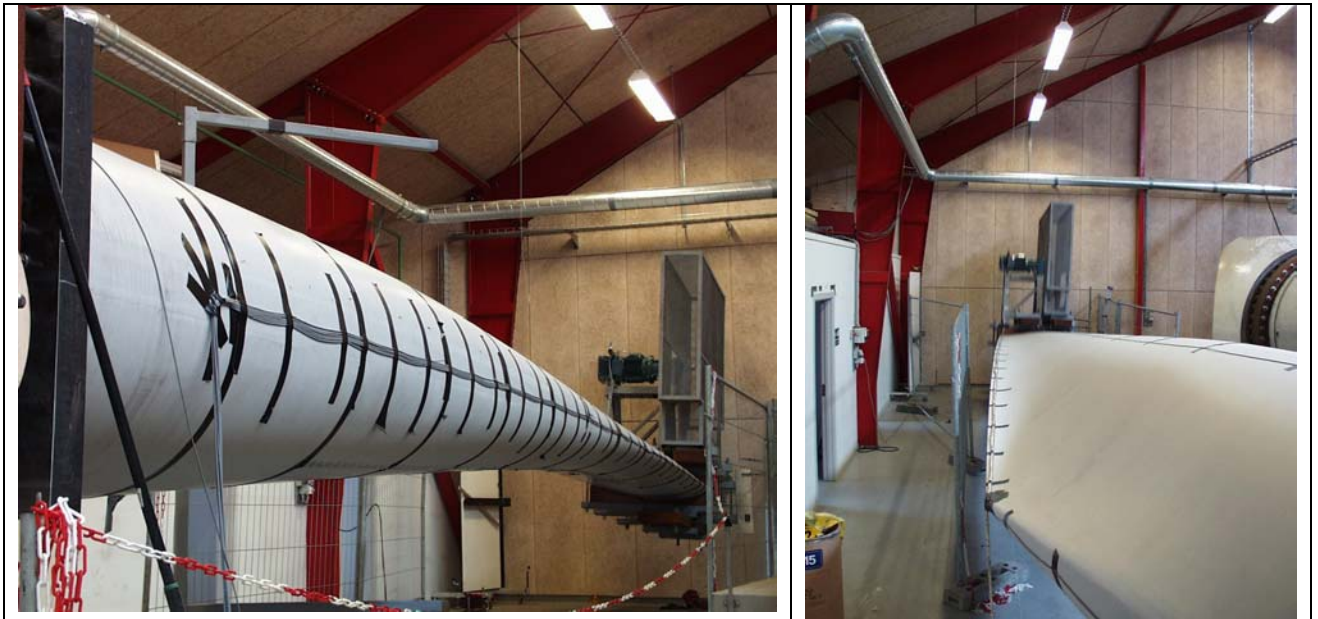
Figure 10. Test configuration at the flapwise fatigue test.

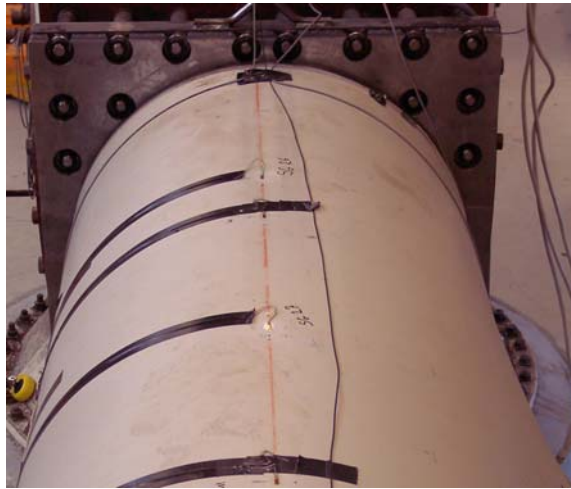
Figure 11. Two additional strain gauges on upwind centre line

Figure 11 and Figure 13. During this second thermal surveillance, at this load level, there was also discovered a hot spot in the root section on the centre line on downwind side of the blade; see Figure 12 and Figure 14.

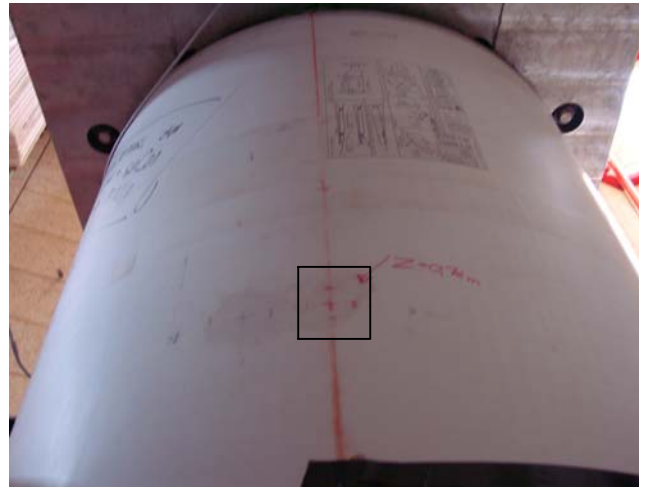
Figure 12. Downwind centre line, hot spot marked with red marker, in the black-lined square, diameter app. 3 [cm].

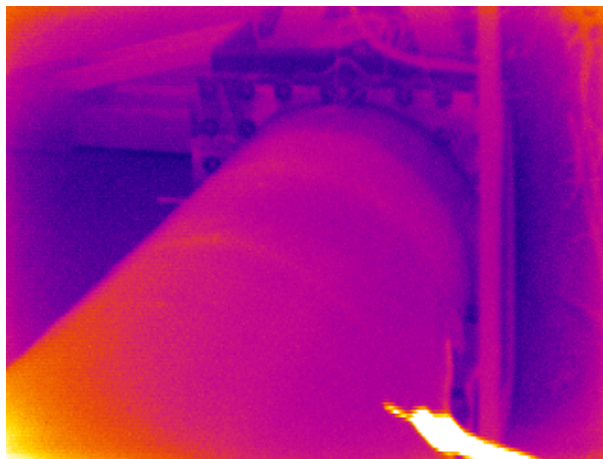
Figure 13. Thermal image of upwind side of root section

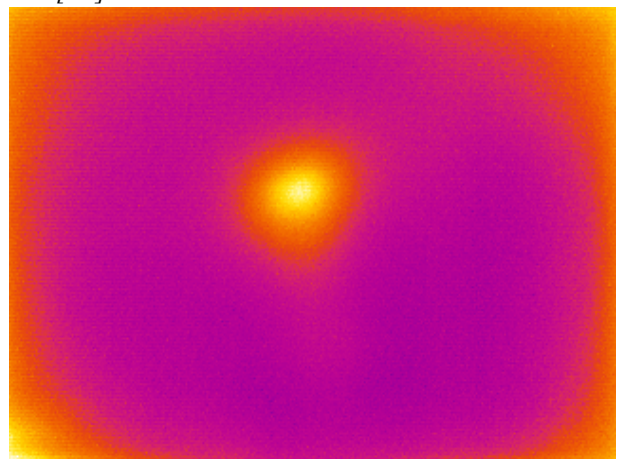
Figure 14. Thermal image of hot spot on centre line of downwind side at the root section

During the thermal session at the second load level there was no propagation in the thermal emission, no increase in the temperature, on the blade, except for the area on the downwind side of the root section where the single hotspot had developed into two spots. The position of these spots is corresponding to the positions of the bushings in the root section. The bushings are for mounting the blade on the hub.

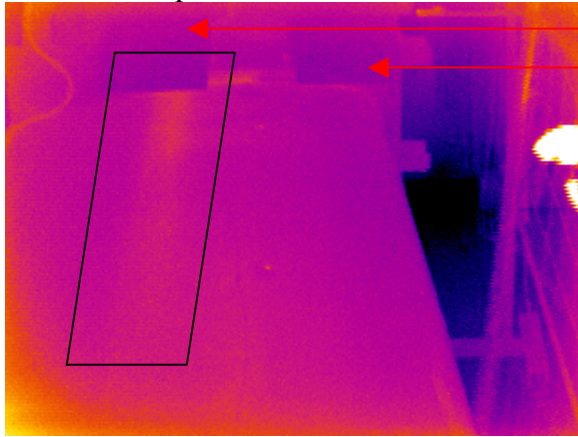
Figure 15. Thermo graphic image of up-wind surface, Z 9 [m] to Z 11.5 [m]. The red arrows are pointing out the two steel-bar pre-loads.

As the test was proceeding, by thermo graphic surveillance at level 3, there was observed a band of higher temperature on the up-wind surface. This band is shown in Figure 15 in the black lined square. The observations showed that the band was narrowed in at $Z = 10$ [m].

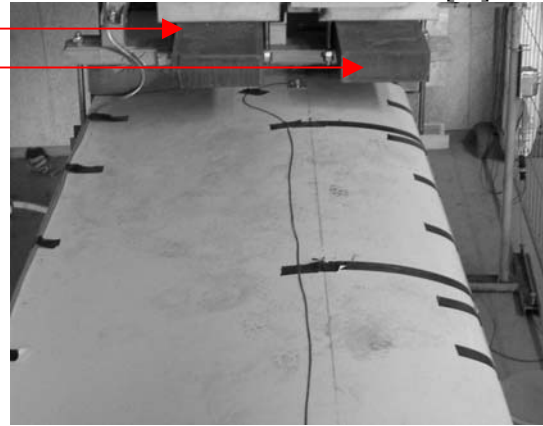
Figure 16. Picture of up-wind surface 9.3 [m] – 11.5 [m]. SG mounted on centre line in $Z = 10$ [m] og $Z = 11$ [m] (where the black gaffa-tape crosses the centre line).

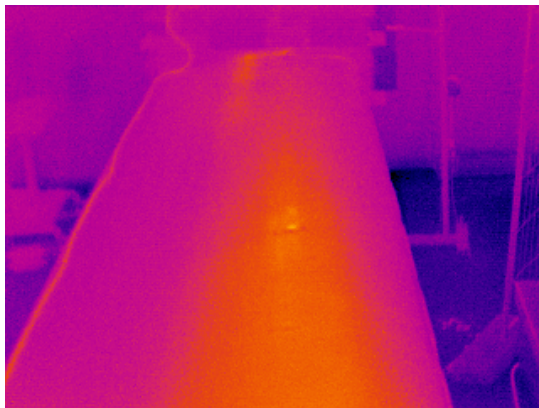
Figure 17. Up-wind surface at level 4

At load level 4 there was no propagation in the area with increased temperature and no change in temperature level. Figure 17 shows the area as the blade was surveyed during level 4.

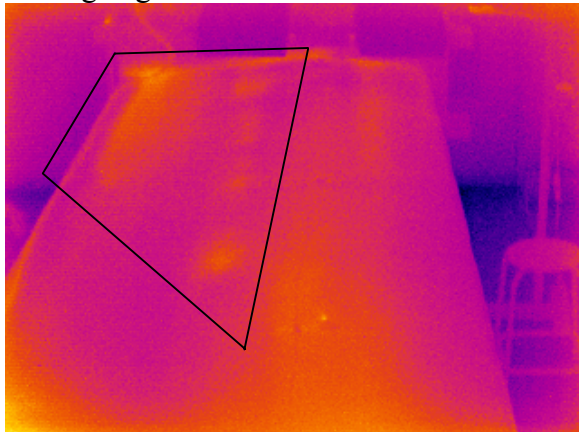
Figure 18. Up-wind surface at level 5. To the right in the black lined area, what used to be a continuous stripe has changed into a number of separated areas. To the left, the area near the trailing edge has increased in temperature.

At level 5 the thermo graphic surveillance showed that the area with higher temperature had changed. What has been a continuous stripe from the exciter frame and one metre towards root section changed to a number of separated areas and additionally the temperature in the trailing edge was increased.

Shortly after the thermal surveillance at level 5 the blade had a visible damage in that area of the trailing edge where an increase in temperature was observed.

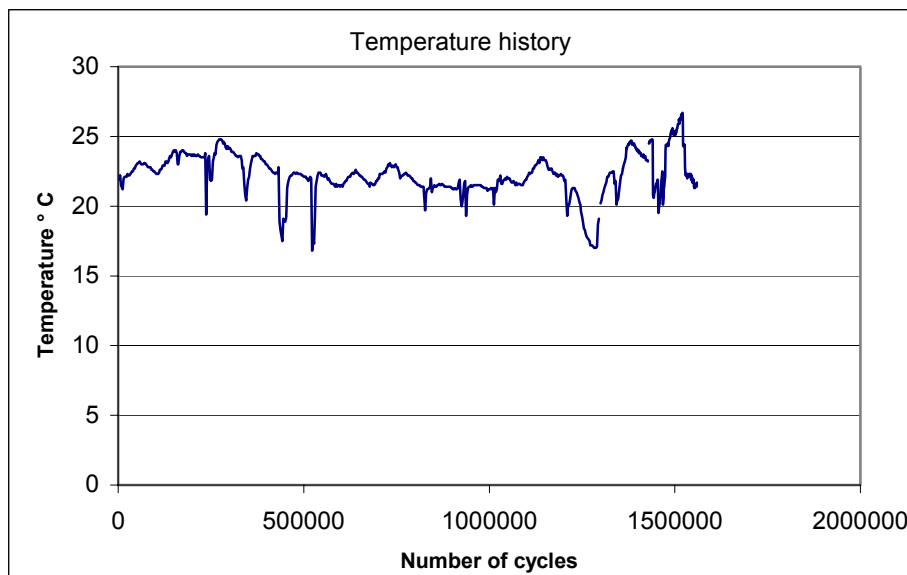
Figure 19. Temperature measurements during flapwise fatigue test blade #4703.

Through the flapwise fatigue test temperature measurements were made. Figure 19 shows the temperature in the environment as a function of the cycles. The data-acquisition-computer measured the temperature and number of cycles. The temperature sensor is positioned on the blade near the root. The sensor is measuring the air temperature in the laboratory.

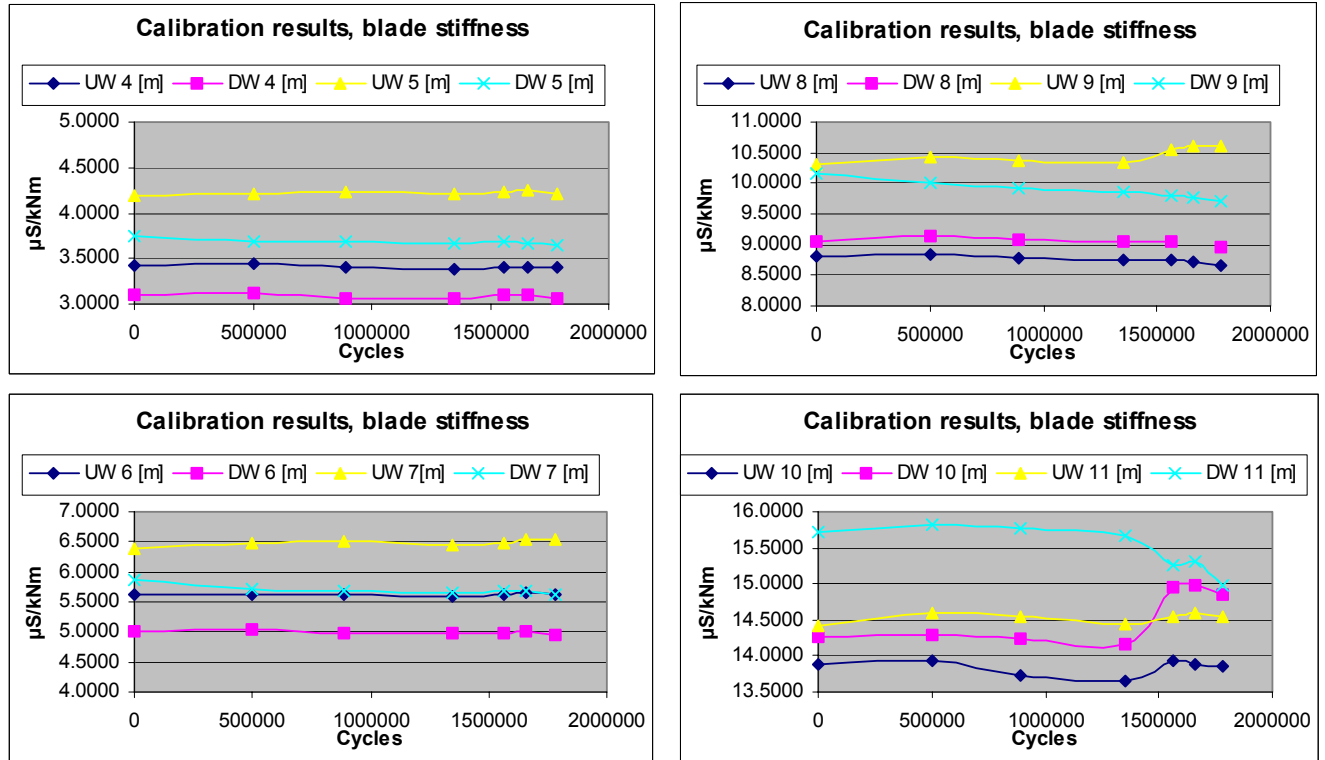
Figure 20. Discrete stiffness distribution for calibration tests of LM 19.1 # 4703, the x-axis is number of cycles applied to the blade

During the fatigue test several calibration tests were performed. The calibration tests were performed as static tests with load applied to make bending towards suction (down wind) side of blade. Figure 20 shows the normative stiffness of the blade for discrete sections of the blade. The measurements show the $\mu\text{S/kNm}$ local stiffness at maximum load for the calibration tests. The graphs are supposed to be linear i.e. no change in stiffness of the blade. The graphs show a change in stiffness for the sections from 9 [m] to 11 [m] as the test is carried out. The change is starting when the test has run for 1.3 million cycles, i.e. app. 500 000 cycles before visual damage was seen on the blade.

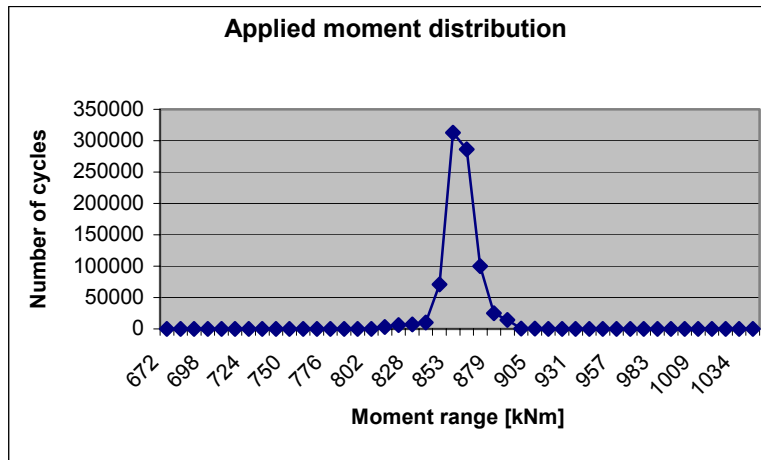
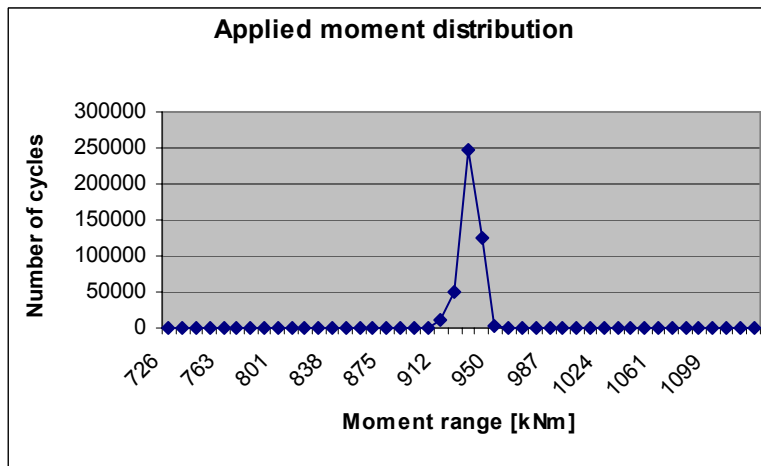
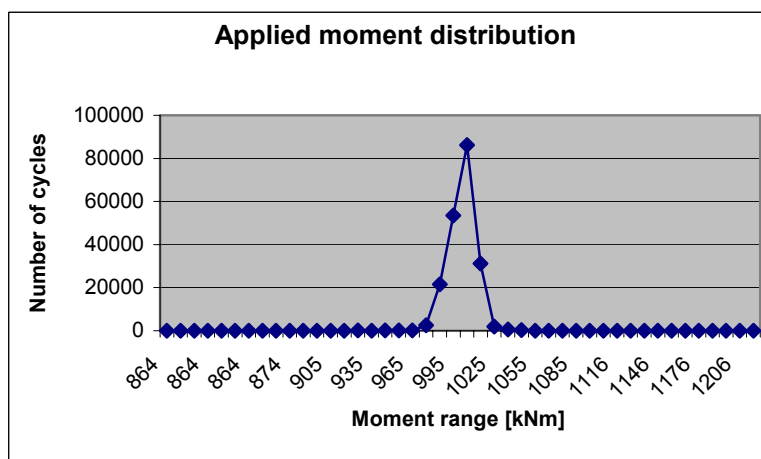
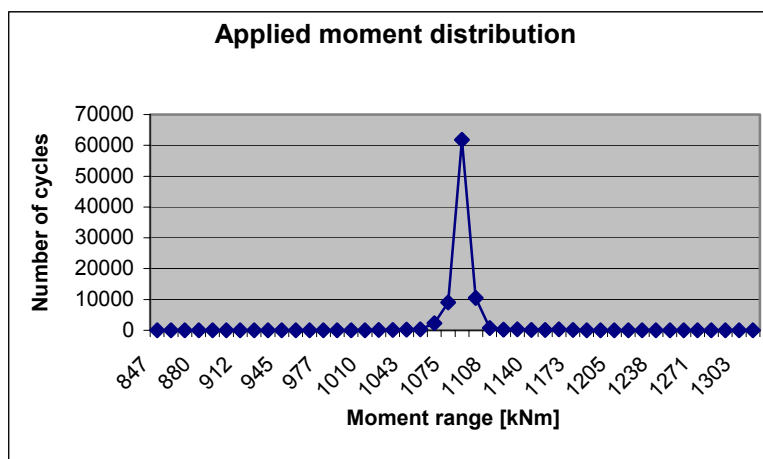
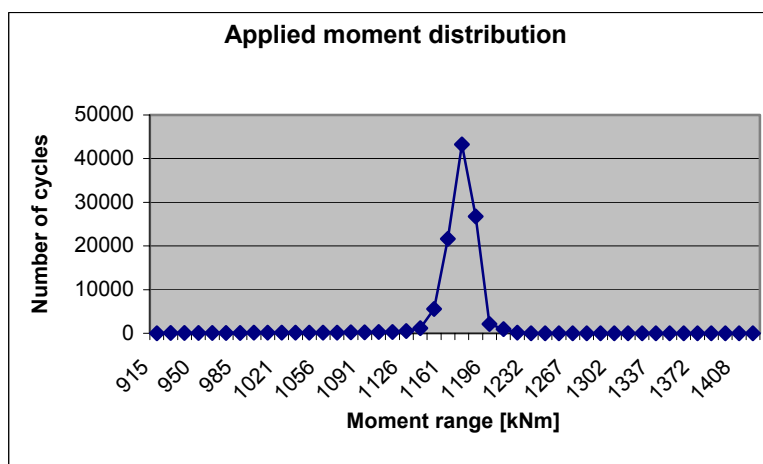
Figure 21. Moment distribution for blade # 4703 at load level 1

Figure 22. Moment distribution for blade # 4703 at load level 2

Figure 23. Moment distribution for blade # 4703 at load level 3

Figure 24. Moment distribution for blade # 4703 at load level 4

Figure 25. Moment distribution for blade # 4703 at load level 5

The number of cycles in Figure 21 - Figure 25 is determined from the data acquisition software.

These moment distributions are used to calculate the equivalent moment applied to the blade. For a more detailed view of the moment distribution see app D.

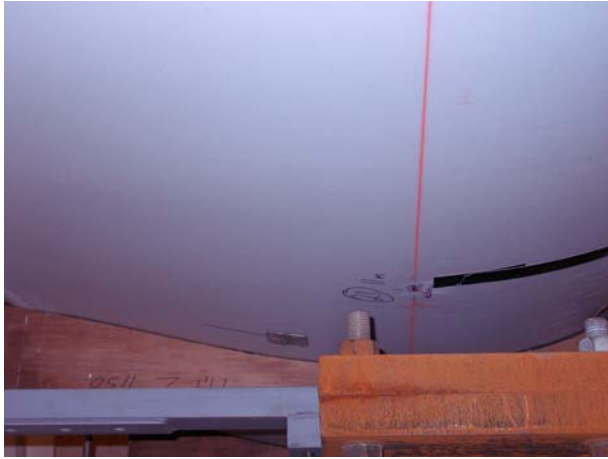
Figure 26. Suction side of blade with part of preload and exciter

side very similar to the picture from the pressure side, i.e. a hot area between the two webs, especially in the area of the web towards trailing edge, see Figure 26 and Figure 28. Hot spots observed in the root section on this blade, were similar to the spots on the first blade. Figure 27 and Figure 29 shows the root section, when the the thermal images were made the root bending moment was 1267 [kNm].

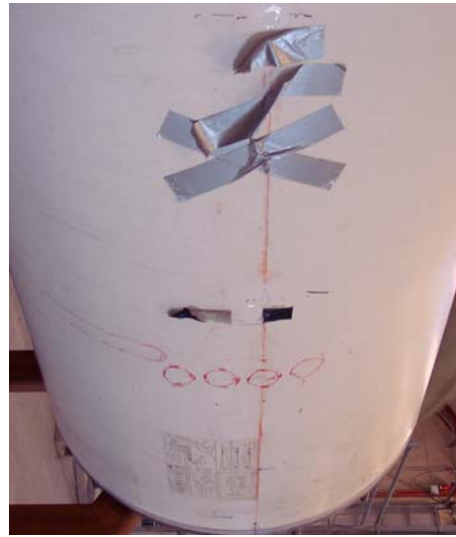
Figure 27. Downwind centre line, hot spot marked with red marker, diameter app. 3 [cm].

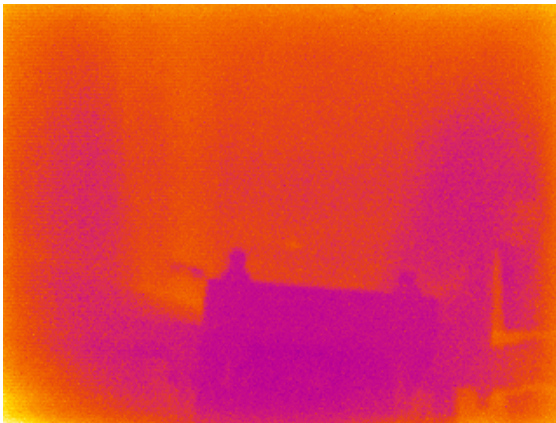
Figure 28. Thermal image of downwind side of exciter area at load level 1086 [kNm]

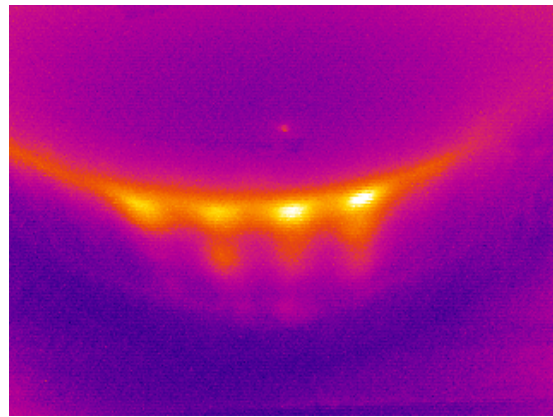
Figure 29. Thermal image of hot spot on centre line of downwind side at the root section at load level 1267 [kNm]

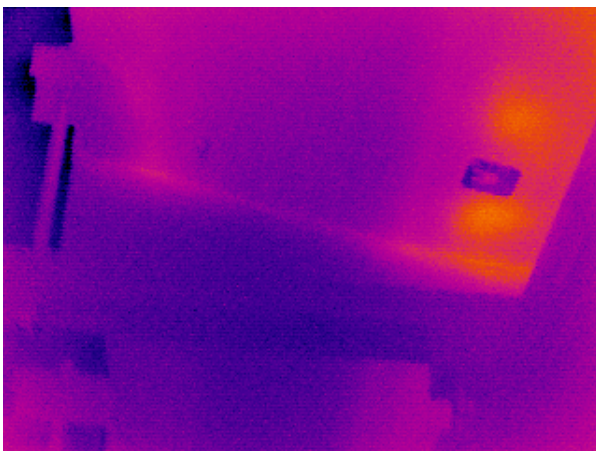
Figure 30. Thermal image of downwind side of exciter area at load level 1368 [kNm]

The propagation in the thermal emission on the blade during test was limited to an increase in the heated area in the root section and, at the very end of the test, a change in heat distribution in the area of the exciter.

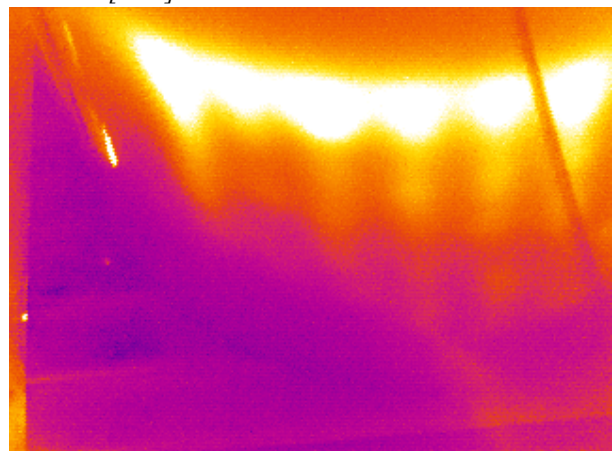
Figure 31. Thermal image of hot spot on centre line of downwind side at the root section at load level 1368 [kNm]

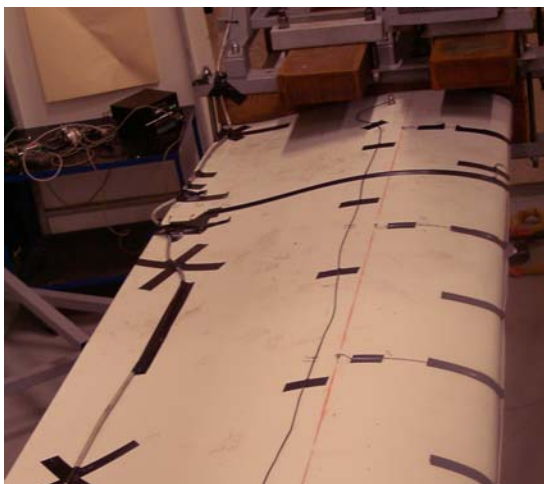
Figure 32. Pressure side of blade, area between 8.5 [m] and exciter

Figure 32 Figure 33 and Figure 34 shows the upwind side of the blade, and the change in thermal emission when the load is increased. A similar picture was seen on the first blade just prior to the damage in the trailing edge. On this blade are observed no damage by visual inspection when the blade was still mounted on the test-rig. Subsequent to the dismounting of the blade a small crack appeared in the trailing edge. The position of the crack was from 10.67 [m] to 10.85[m].

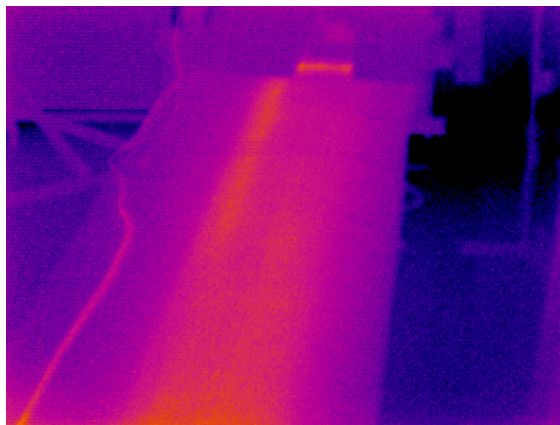
Figure 33. Thermal image of upwind side of exciter area at load level 1267 [kNm]

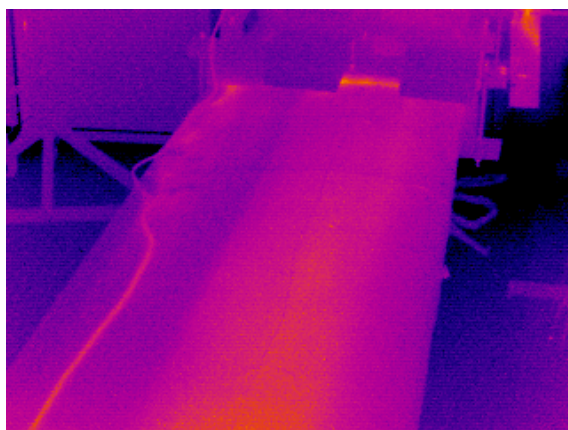
Figure 34. Thermal image of upwind side of exciter area at load level 1368 [kNm]

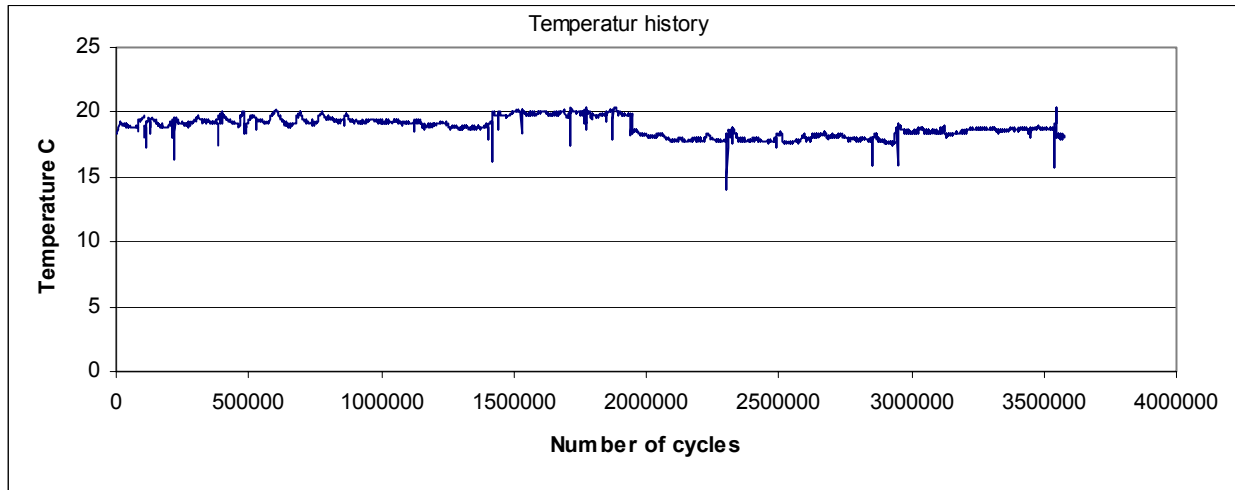
Figure 35. Temperature measurements during flapwise fatigue test.

Through the flapwise fatigue test temperature measurements were made. Figure 35 shows the temperature in the environment as a function of the cycles. The data-acquisition-computer measured the temperature and number of cycles.

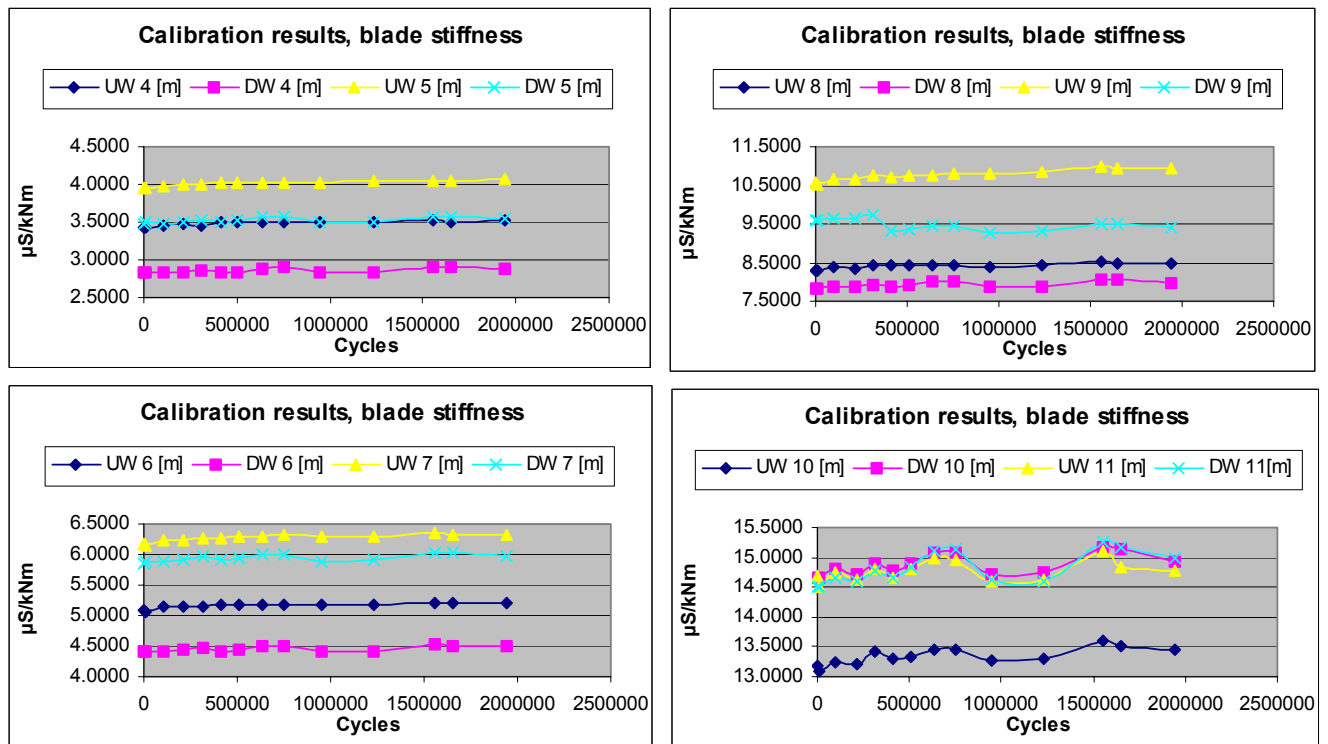
Figure 36. Discrete stiffness distribution for calibration tests of LM 19.1 # 4706, the x-axis is number of cycles applied to the blade

app. 1 500 000 cycles before visual damage was seen on the blade.

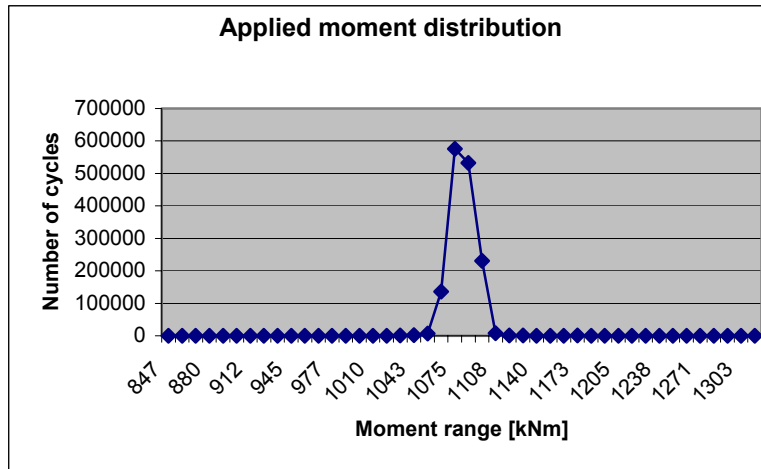
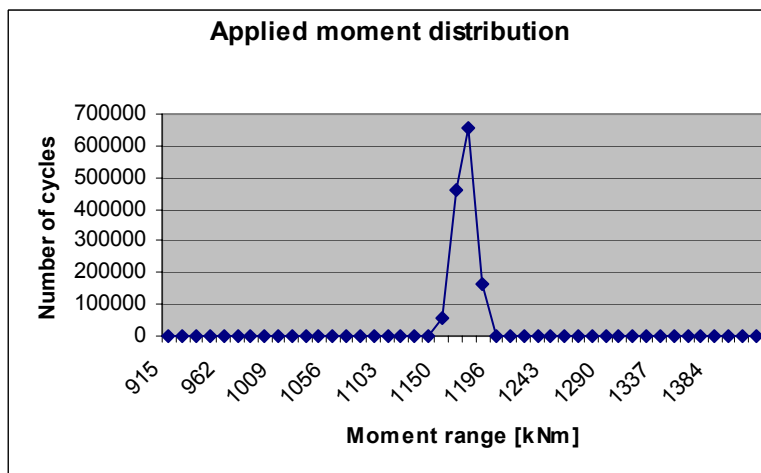
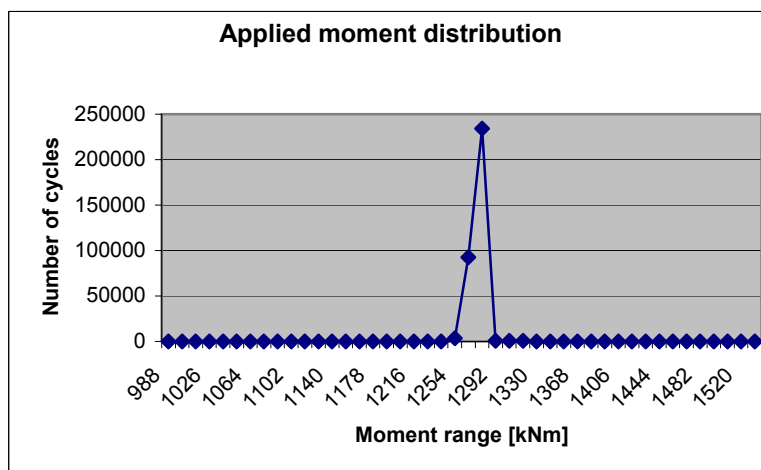
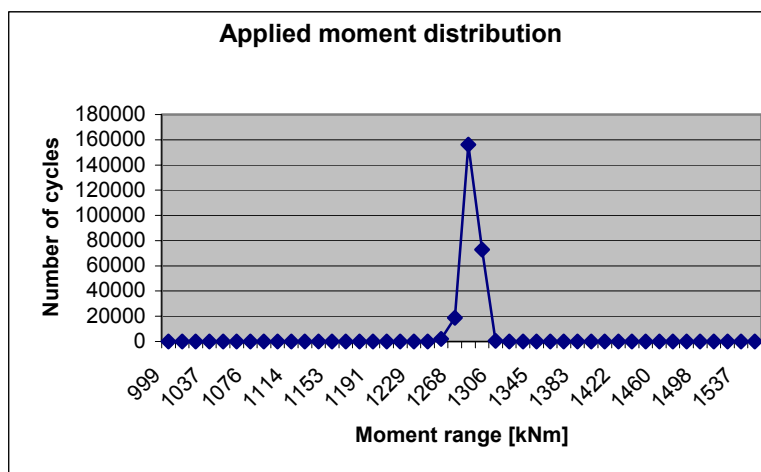
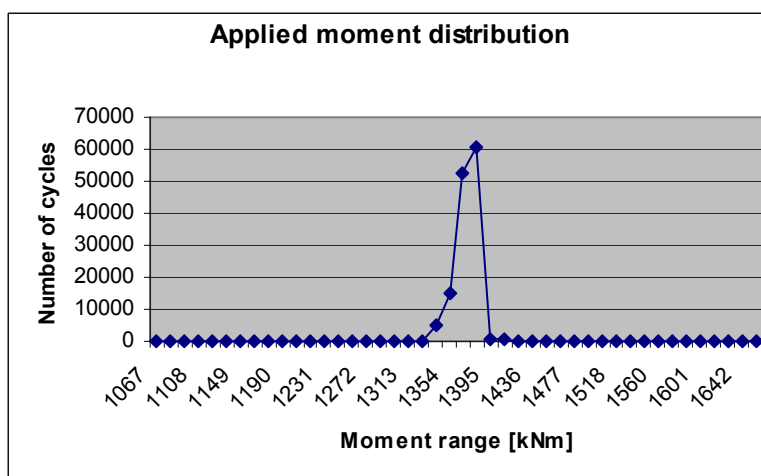
Figure 37. Moment distribution for blade # 4706 at load level 1

Figure 38. Moment distribution for blade # 4706 at load level 2

Figure 39. Moment distribution for blade # 4706 at load level 3

Figure 40. Moment distribution for blade # 4706 at load level 4

Figure 41. Moment distribution for blade # 4706 at load level 5

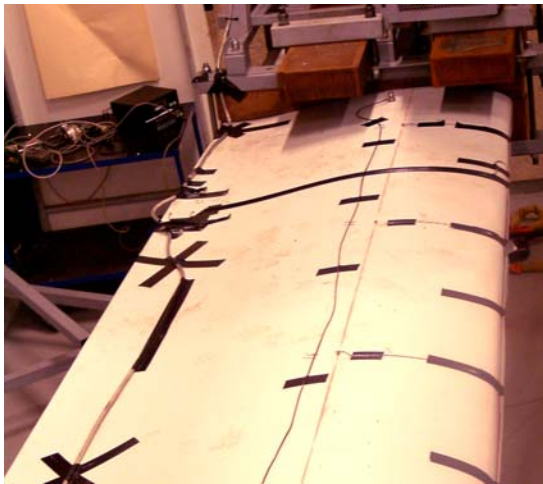
Figure 42. Pressure side of blade, area between 8.5 [m] and exciter. This picture is from blade 4706, this explains the difference in cabling

Figure 42, Figure 43 and Figure 44 show the upwind side of the blade, and the thermal emission from the blade. A similar picture was seen on the first two blades. On this blade are observed no damage by visual inspection but as the test of this blade was terminated a minor change in strain level were observed for some of the SG.

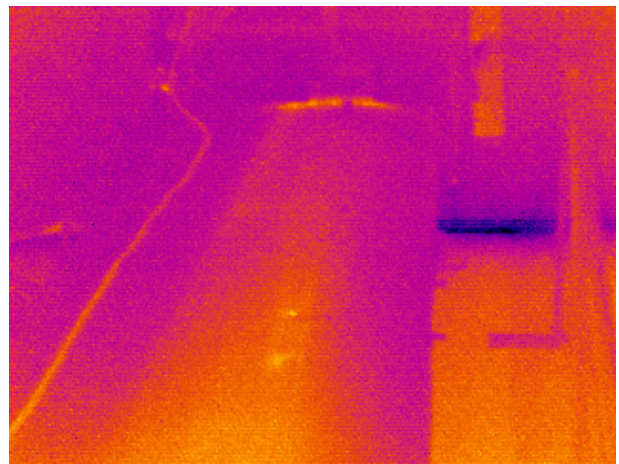
Figure 43. Thermal image of upwind side of exciter area at load level 1173 [kNm]

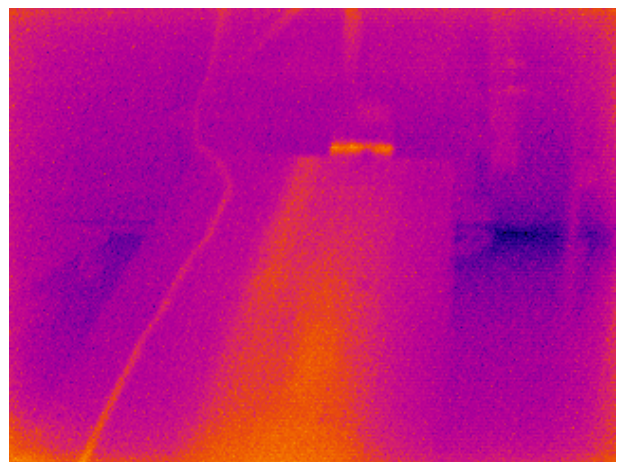
Figure 44. Thermal image of upwind side of exciter area at load level 1173 [kNm]
